THE PUZZLE OF THE CRASH OF FEDEX FLIGHT 1478: IMPLICATIONS FOR COLOUR VISION STANDARDS IN AVIATION

Arthur Pape,
MBBS
Boris Crassini,
BA(Hons) PhD

Pape A, Crassini B. The puzzle of the crash of FedEx Flight 1478: Implications for colour vision standards in aviation. J Aust Soc Aerospace Med 2013;8:28-31

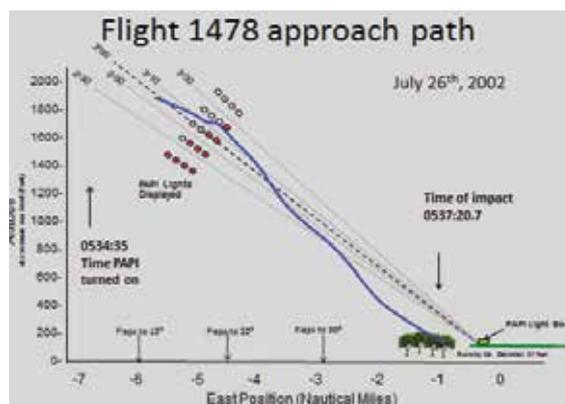
Figure 1.

descent in order to intercept the 'proper' approach angle of 3°. Similarly, observation of a pattern of four red PAPI lights should result in the pilot and crew aborting the approach, and initiating a 'go round'. It is clear from the flight profile shown in Figure 1 that although during the final three minutes of Flight 1478, a pattern of four red PAPI lights was supposedly visible to the crew, their actions were more consistent with perception of a pattern of four white PAPI lights ('lower the nose of the aircraft') than perception of four red PAPI lights ('go round').

The blue line shows the reconstructed flight profile of Flight 1478 over about the final six nautical miles and about final three minutes before it crashed into trees short of Runway 9. Also shown are the five wedge-shaped sectors of vertical airspace radiating from the Runway 9 PAPI device, and the different patterns of white and red PAPI lights supposedly visible in each sector, corresponding with the final approach of Flight 1478. The distances to run at which the various stages of flaps were set are shown on the horizontal axis. (Adapted from NTSB²).

Assumption/Fact 2: The Runway 9 PAPI device was providing veridical colour-coded information to the crew as to the dangerously low approach angle being flown (viz., four red PAPI lights; see Figure 1).

As already noted, the actions of the crew of Flight 1478 as reflected in Figure 1 in the reconstructed flight profile of the final stages of Flight 1478 are *not consistent with* the crew seeing four red PAPI lights¹. However, these actions *are* consistent with the crew seeing four *white* PAPI lights. This begs the question: 'Can red PAPI lights look like, and therefore be confused with, white PAPI lights, and if so, under what conditions?' Two different answers to this question seem to be provided in the NTSB Report, and can be summarised as follows:
